**Flood Control Project Maintenance  
Levee Inspections**  
**LMA District Cover Sheet**  
**Spring 2019 Levee Inspection Results**

**Reclamation District No. 0003 Grand Island**

**Spring 2019 Levee Inspection Results**

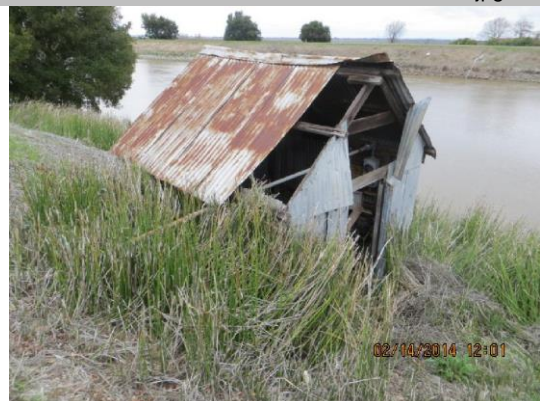
Photo 2 of 3 : UCIP\_SP\_2019\_53292\_55541.jpg

Pumphouse on WS slope next to slant pump.

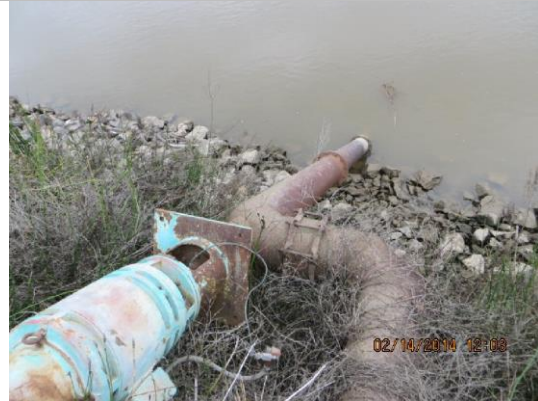
Photo 3 of 3 : UCIP\_SP\_2019\_53292\_55540.jpg

Item	DWR UCIP Field Study			38.281302 °	38.281302 °	
				-121.549338 °	-121.549338 °	
DWR ID	22371					
Comment Code						
Inspector Comment						
FS_ID:53292 DS_ID:22371 EP_NO: N/A Repair Type: Urgent Crossing Status: Found UCIP Comments: 07/20/2018 Everything appears to be the same as last time. No changes have been made. No new pipe has been put in. Crossing remains "Urgent" because of the holes visible in 2014. (DWR UCIP - A. McDonald)07/06/2016 Heavy vegetation prevented visibility. Per RD0003 president David Robertson, WS erosion repaired last Spring. Could not fully see any repair work done. Need to return when vegetation cleared. Appears abandoned and if so should be done properly. (DWR UCIP - K. Fazel)02/14/2014 Pipe rusted through on WS slope. Appears abandoned and should be done so properly. Erosion of WS slope under pipe on WS toe. (DWR FPIIB - G. Wylie) FIELD_STRUCT_DESC: *ABANDONED* 12-inch steel irrigation discharge pipe through the levee, invert elevation 7 feet below the crown. Slant pump next to old pump house on the waterside (WS) slope. 2-inch filler pipe at the same location. 4-foot by 8-foot concrete distribution box and standpipe at the landside (LS) toe. (Plans to replace a 12-inch steel pipe through the levee authorized under Permit No. 7082, 1974 - Pacific Fruit Farms). Permit was canceled. Original pipe remains. [Additional Reference(s): DWR Levee Log, 1993. USACE Sacramento O&M Manual 104, February 1960, (RM 30.30)]. FS Date: 7/20/2018

Slant pump on WS slope.

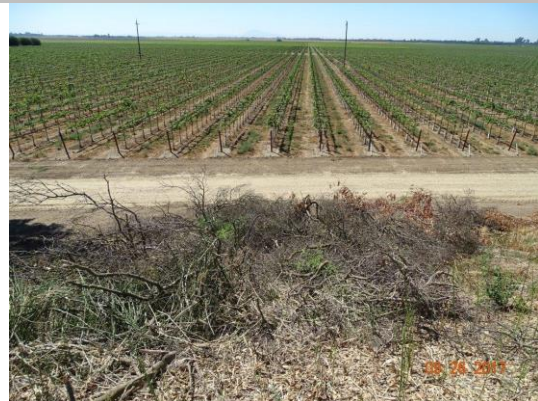
Photo 1 of 1 : SP\_2019\_RD0003\_25\_134\_20190311\_00098.jpg

LM Start	15.37	Rating **	M	Issue No.	134
LM End	15.37	Issue Type +	Ma	Location *	LS
Category	Earthen Levee			GPS Latitude/Longitude	
				Start	End
Item	Encroachments			38.282243 °	38.282243 °
				-121.550917 °	-121.550917 °
DWR ID	DWR_RD0003_02_s_2017_134				
Comment Code					
PR : Prunings					
Inspector Comment					
Remove prunings from the landside slope.

Looking southwest at the landside slope.

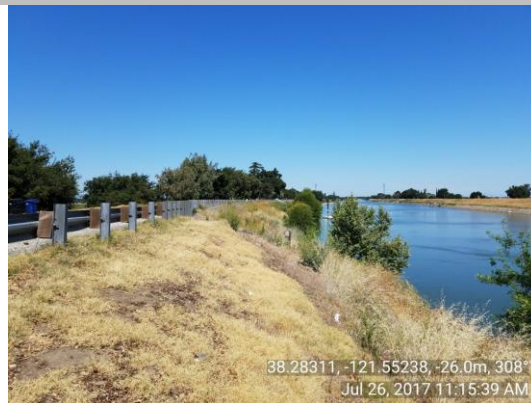
Photo 2 of 3 : SP\_2019\_RD0003\_25\_149\_20190311\_00124.jpg

LM Start	15.46	Rating **	A/W	Issue No.	149 (cont)
LM End	15.47	Issue Type +	Ma	Location *	
Category	Supplemental			GPS Latitude/Longitude	
				Start	End
Item	2017 Storm Damage			38.283119 °	38.283172 °
				-121.552250 °	-121.552347 °
DWR ID	DWR_RD0003_02_f _ 2017_149				
Comment Code					
Inspector Comment					
Levee Evaluation Comments					
Description:District station 816+64 to 816+97, Sec. 16, T. 5 N. R. 4 E., M.D.M. Approximately 33 linear feet of erosion exists along the water side slope of the Sacramento River (Unit 2). The erosion commences approximately 1/2 ofthe way down the slope from the crown and extends into the rip rap. A section of rip rap has eroded away in this location.					
Site ID No:283					
Site Designation:LMA-109					
Repair Type: Erosion					
Rating:Area of Concern					
Field Date:7/26/2017					
Notes:

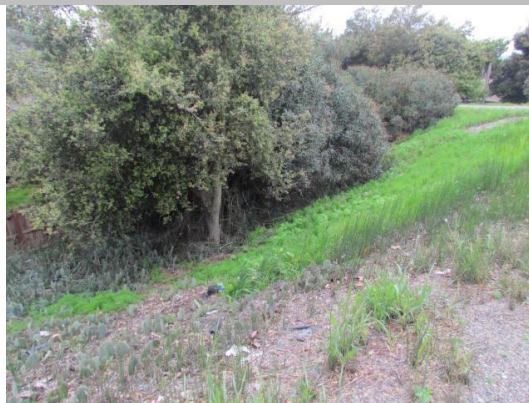
Photo 1 of 1 : SP\_2019\_RD0003\_25\_94\_20190311\_00071.jpg

LM Start	15.47	Rating **	U	Issue No.	94
LM End	15.47	Issue Type +	En	Location *	LS
Category	Earthen Levee			GPS Latitude/Longitude	
				Start	End
Item	Vegetation			38.283050 °	38.283050 °
				-121.552506 °	-121.552506 °
DWR ID	DWR_RD0003_02_s_2013_94				
Comment Code					
V6 : Landscaping					
Inspector Comment					
There is dense landscaping on the landside slope and toe.

Looking northwest at landscape at landward toe.

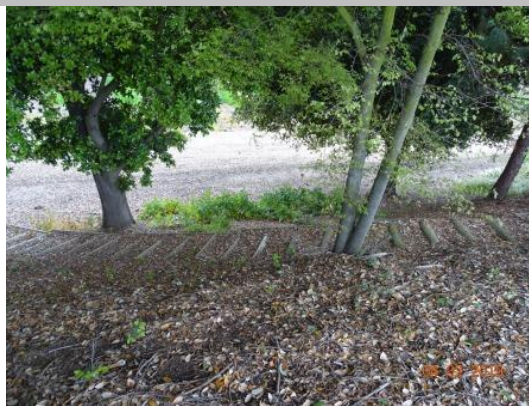
Photo 1 of 1 : SP\_2019\_RD0003\_25\_117\_20190404\_00328.jpg

LM Start	15.56	Rating **	M	Issue No.	117
LM End	15.56	Issue Type +	En	Location *	LS
Category	Earthen Levee			GPS Latitude/Longitude	
				Start	End
Item	Encroachments			38.283910 °	38.283910 °
				-121.553807 °	-121.553807 °
DWR ID	DWR_RD0003_02_s_2019_117				
Comment Code					
ST : Stairway					
Inspector Comment					
There is a stairway on the slope.

View looking downslope at stairway on the landside slope (Spring 2019).

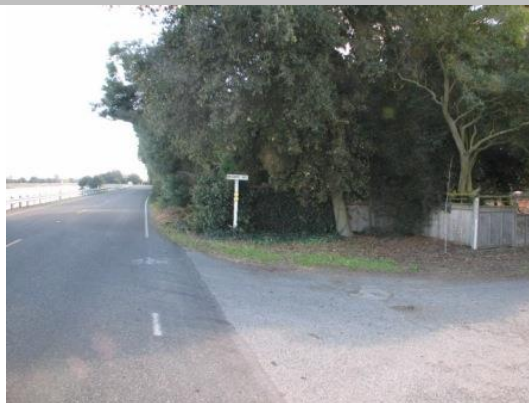
Photo 2 of 2 : SP\_2019\_RD0003\_25\_79\_20190311\_00058.jpg

LM Start	15.58	Rating **	U	Issue No.	79 (cont)	
LM End	15.68	Issue Type +	En	Location *	LS	
Category	Earthen Levee			GPS Latitude/Longitude		
				Start		End
Item	Vegetation			38.284124 °		38.285129 °
				-121.554084 °		-121.555342 °
DWR ID	DWR_RD0003_02_s_2012_79					
Comment Code						
V6 : Landscaping						
Inspector Comment

Looking southeast at landscaping on levee slope and toe obstruct access and visibility.

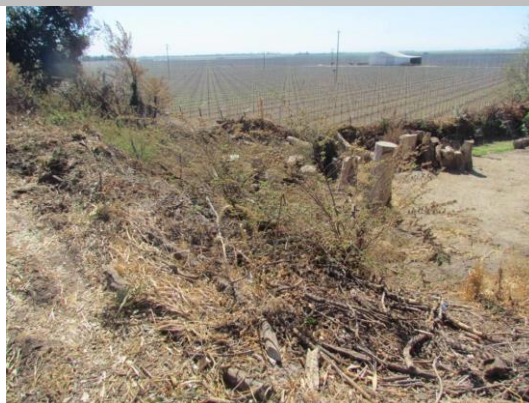
Photo 1 of 2 : SP\_2019\_RD0003\_25\_144\_20190311\_00116.jpg

LM Start	15.61	Rating **	U	Issue No.	144
LM End	15.61	Issue Type +	En	Location *	LS
Category	Earthen Levee			GPS Latitude/Longitude	
				Start	End
Item	Encroachments			38.284393 °	38.284393 °
				-121.554319 °	-121.554319 °
DWR ID	DWR_RD0003_02_f_2015_144				
Comment Code					
PR : Prunings					
Inspector Comment					
Prunings piled on the landside slope and toe along with tree stumps.

Looking south at prunings on landward slope. (Fall 2016)

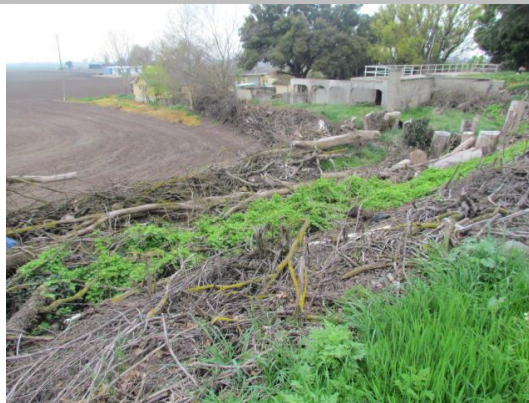
Photo 2 of 2 : SP\_2019\_RD0003\_25\_144\_20190311\_00117.jpg

LM Start	<b>15.61</b>	Rating **	U	Issue No.	<b>144 (cont)</b>
LM End	<b>15.61</b>	Issue Type +	En	Location *	LS

Looking southwest at prunings on landward slope and toe. (Spring 2016)

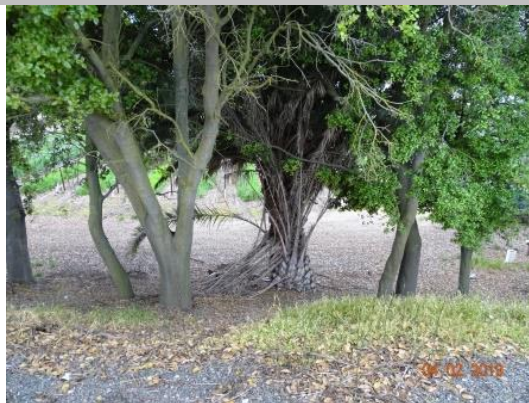
Photo 1 of 1 : SP\_2019\_RD0003\_25\_116\_20190404\_00327.jpg

LM Start	15.70	Rating **	M	Issue No.	116
LM End	15.70	Issue Type +	Ma	Location *	LS
Category	Earthen Levee			GPS Latitude/Longitude	
				Start	End
Item	Trim / Thin Trees			38.285349 °	38.285349 °
				-121.555548 °	-121.555548 °
DWR ID	DWR_RD0003_02_s_2019_116				
Comment Code					
T1 : Trim trees to at least five feet above ground level.					
Inspector Comment					
Remove fallen palm tree limbs.

View looking downslope at fallen palm limbs at the bottom of the landside slope (Spring 2019).

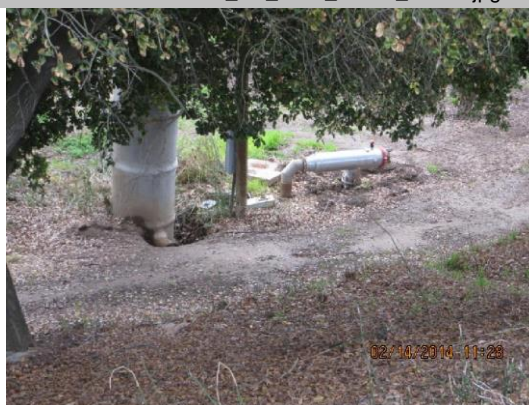
Photo 1 of 3 : UCIP\_SP\_2019\_30084\_55485.jpg

LM Start	15.71	Rating **	M	Issue No.	1000	
LM End	15.71	Issue Type +	En	Location *		
Category	Supplemental			GPS Latitude/Longitude		
				Start	End	
Item	DWR UCIP Field Study			38.285491 °	38.285491 °	
				-121.555625 °	-121.555625 °	
DWR ID	22334

Comment Code						
Inspector Comment						
FS_ID:30084 DS_ID:22334 EP_NO: 2137 Repair Type: Non-Urgent Crossing Status: Found UCIP Comments: Appears abandoned and if so should be done so properly. Leak apparent at pipe connection to concrete standpipe at LS toe. Good candidate for video inspection. FIELD_STRUCT_DESC: 12-inch steel irrigation discharge pipe through the levee, invert elevation 9 feet below the crown. Slant pump on the waterside (WS) slope. 44-inch concrete standpipe at the landside (LS) toe. 1.5-inch electrical conduit through the levee at the same location. Filter plant at the LS toe. (Plans for the installation of a 12-inch irrigation pipe through the levee authorized under Permit No. 2137, 1955 - Pacific Fruit Exchange). [Additional Reference(s): DWR Levee Log, 1993, 14-inch pipe referenced, 6.5 feet below the crown. USACE Sacramento O&M Manual 104, February 1960, (RM 30.76)]. FS Date: 2/14/2014

Concrete standpipe, filter plant, power pole and meter on LS toe.

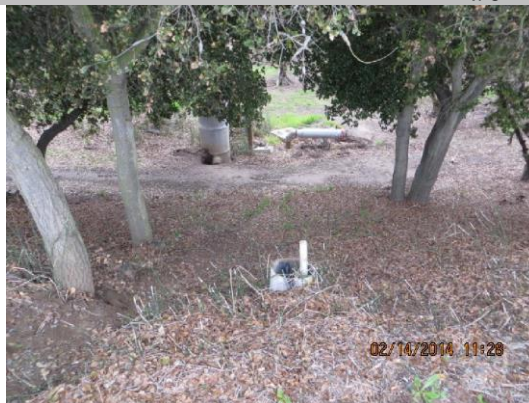
Photo 2 of 3 : UCIP\_SP\_2019\_30084\_55484.jpg

LM Start	15.71	Rating **	M	Issue No.	1000 (cont)
LM End	15.71	Issue Type +	En	Location *

Siphon breaker on LS shoulder.

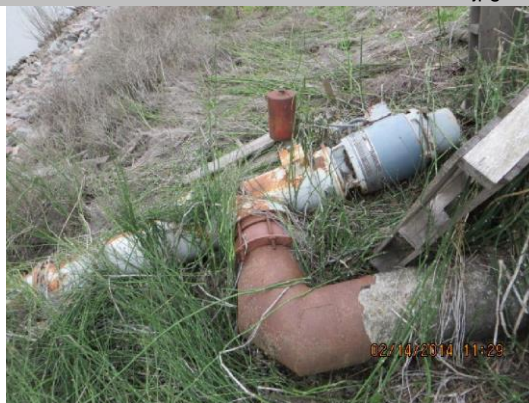
Photo 3 of 3 : UCIP\_SP\_2019\_30084\_55483.jpg

Slant pump on WS slope.

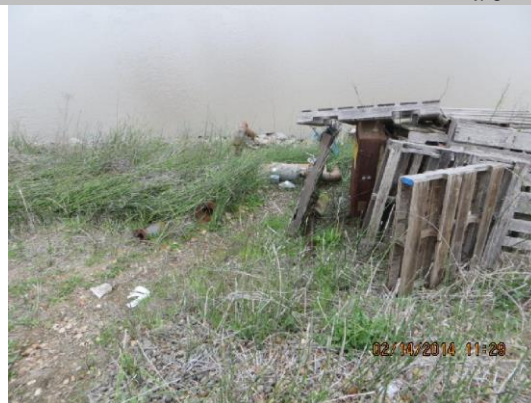
Photo 1 of 3 : UCIP\_SP\_2019\_30083\_55482.jpg

LM Start	15.71	Rating **	M	Issue No.	1001
LM End	15.71	Issue Type +	En	Location *	
Category	Supplemental			GPS Latitude/Longitude	
				Start	End
Item	DWR UCIP Field Study			38.285500 °	38.285500 °
				-121.555635 °	-121.555635 °
DWR ID	22375				
Comment Code					
Inspector Comment					
FS_ID:30083 DS_ID:22375 EP_NO: 7356 Repair Type: Non-Urgent Crossing Status: Found UCIP Comments: Pipe debris on WS slope. FIELD_STRUCT_DESC: 10-inch steel irrigation discharge pipe through the levee, 6.5 feet below the crown. 8-inch pipe on the landside (LS) slope. 6-inch pipe on the waterside (WS) slope. Pump and gate valve on the WS slope. (Plans to install a 6-inch pipe and pump on the WS slope of the levee authorized under Permit No. 7356, 1971 - Pacific Fruit Farms. USACE, Unit No. 15, 1969). [Additional Reference(s): DWR Levee Log, 1993]. FS Date: 2/14/2014

LM Start	15.71	Rating **	M	Issue No.	1001 (cont)
LM End	15.71	Issue Type +	En	Location *

Pump on WS slope next to slant pump.

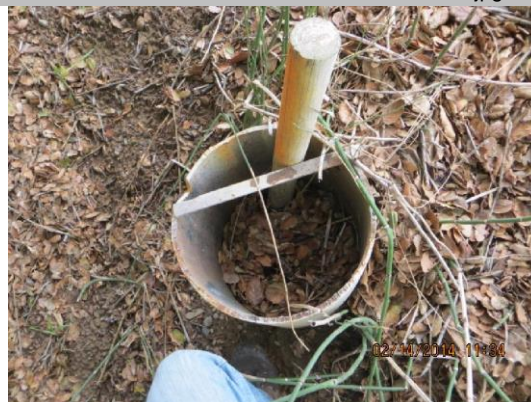
Photo 2 of 3 : UCIP\_SP\_2019\_30083\_55481.jpg

Vent or Siphon Breaker in 14-inch steel riser on LS slope.

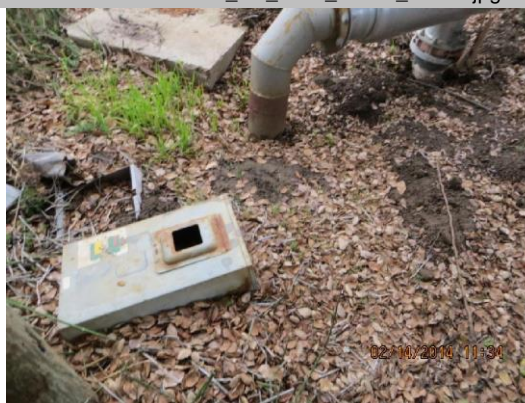
Photo 3 of 3 : UCIP\_SP\_2019\_30083\_55480.jpg

LM Start	15.71	Rating **	M	Issue No.	1001 (cont)	
LM End	15.71	Issue Type +	En	Location *		
Category	Supplemental			GPS Latitude/Longitude		
				Start		End
Item	DWR UCIP Field Study			38.285500 °		38.285500 °
				-121.555635 °		-121.555635 °
DWR ID	22375					
Comment Code						
Inspector Comment						
FS_ID:30083 DS_ID:22375 EP_NO: 7356 Repair Type: Non-Urgent Crossing Status: Found UCIP Comments: Pipe debris on WS slope. FIELD_STRUCT_DESC: 10-inch steel irrigation discharge pipe through the levee, 6.5 feet below the crown. 8-inch pipe on the landside (LS) slope. 6-inch pipe on the waterside (WS) slope. Pump and gate valve on the WS slope. (Plans to install a 6-inch pipe and pump on the WS slope of the levee authorized under Permit No. 7356, 1971 - Pacific Fruit Farms. USACE, Unit No. 15, 1969). [Additional Reference(s): DWR Levee Log, 1993]. FS Date: 2/14/2014

Pipe and filter plant on LS toe.

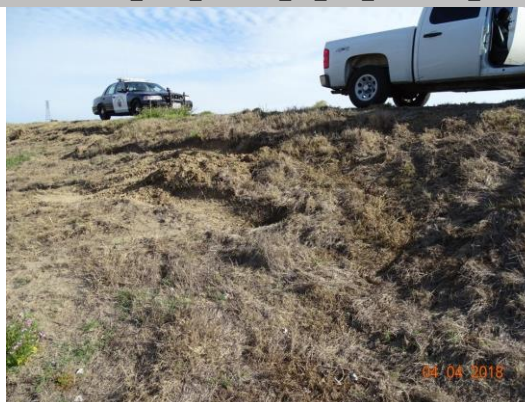
Photo 1 of 1 : SP\_2019\_RD0003\_25\_124\_20190311\_00086.jpg

LM Start	15.94	Rating **	M	Issue No.	124
LM End	15.94	Issue Type +	Ma	Location *	LS
Category	Earthen Levee			GPS Latitude/Longitude	
				Start	End
Item	Slope Stability			38.288009 °	38.288009 °
				-121.558398 °	-121.558398 °
DWR ID	DWR_RD0003_02_s_2018_124				
Comment Code					
S3 : Repair the levee slope damaged by vehicle traffic and prevent access where possible.					
Inspector Comment					
There is vehicle erosion on the landside slope.

Vehicle erosion on landside slope should be repaired.

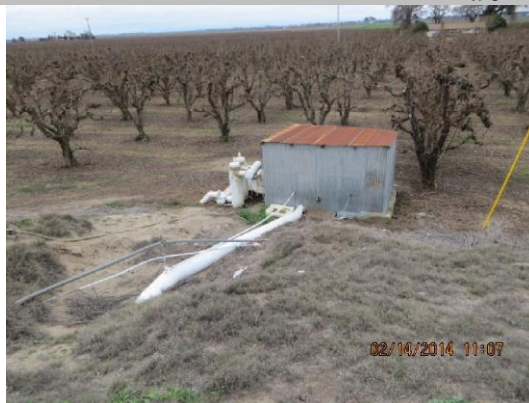
Photo 1 of 3 : UCIP\_SP\_2019\_30004\_55382.jpg

Comment Code					
Inspector Comment					
FS_ID:30004 DS_ID:22376 EP_NO: 17382 Repair Type: Non-Urgent Crossing Status: Found UCIP Comments: Tank on LS slope not listed in permit. FIELD_STRUCT_DESC: 12-inch steel irrigation discharge pipe through the levee, 10 feet below the crown. Pump and butterfly valve in a pump house at the landside (LS) toe. Siphon breaker on the waterside (WS) slope. Tank on the LS slope. (Plans to abandon in place two existing deteriorated pipes and install a 12-inch steel irrigation pipe and a 2-inch steel irrigation pipe through the crown and on the slopes of the levee authorized under Permit No. 17382, 2001 - Ferreira Estate Company, DCC Engineering Company, Inc). [Additional Reference(s): DWR Levee Log, 1993, referenced as 5.2 feet below the crown]. FS Date: 2/14/2014

Pump in pumphouse on LS toe.

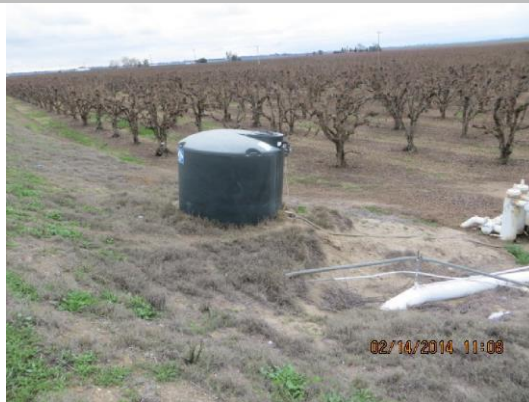
Photo 2 of 3 : UCIP\_SP\_2019\_30004\_55381.jpg

LM Start	<b>16.04</b>	Rating **	M	Issue No.	<b>1002 (cont)</b>
LM End	<b>16.04</b>	Issue Type +	En	Location *

Tank on LS slope not noted in permit.

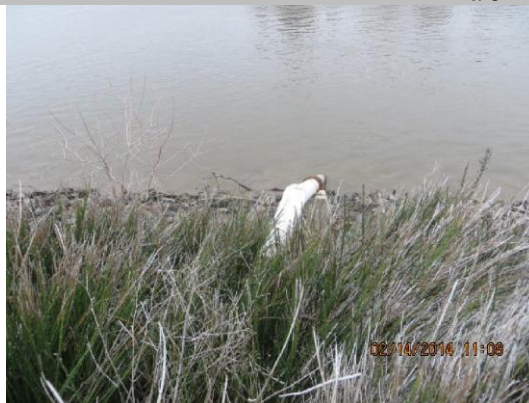
Photo 3 of 3 : UCIP\_SP\_2019\_30004\_55380.jpg

Item	DWR UCIP Field Study			38.289098 °	38.289098 °	
				-121.559597 °	-121.559597 °	
DWR ID	22376					
Comment Code						
Inspector Comment						
FS_ID:30004 DS_ID:22376 EP_NO: 17382 Repair Type: Non-Urgent Crossing Status: Found UCIP Comments: Tank on LS slope not listed in permit. FIELD_STRUCT_DESC: 12-inch steel irrigation discharge pipe through the levee, 10 feet below the crown. Pump and butterfly valve in a pump house at the landside (LS) toe. Siphon breaker on the waterside (WS) slope. Tank on the LS slope. (Plans to abandon in place two existing deteriorated pipes and install a 12-inch steel irrigation pipe and a 2-inch steel irrigation pipe through the crown and on the slopes of the levee authorized under Permit No. 17382, 2001 - Ferreira Estate Company, DCC Engineering Company, Inc). [Additional Reference(s): DWR Levee Log, 1993, referenced as 5.2 feet below the crown]. FS Date: 2/14/2014

Pipe visible on WS slope.

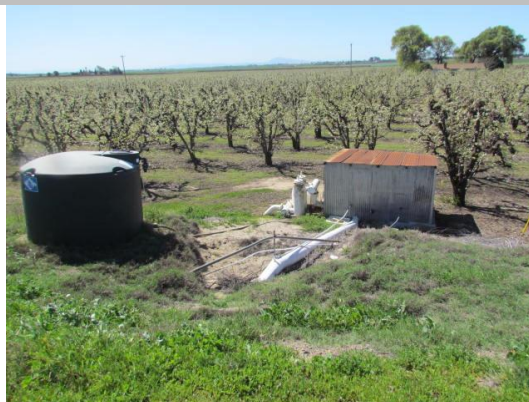
Photo 1 of 2 : SP\_2019\_RD0003\_25\_75\_20190311\_00048.jpg

LM Start	16.04	Rating **	M	Issue No.	75
LM End	16.04	Issue Type +	En	Location *	LS
Category	Earthen Levee			GPS Latitude/Longitude	
				Start	End
Item	Encroachments			38.289126 °	38.289126 °
				-121.559631 °	-121.559631 °
DWR ID	DWR_RD0003_02_s_2014_75				
Comment Code					
TA : Tank					
Inspector Comment					
A tank is located next to an irrigation system on the landside slope. No permit for this tank was found.

Looking west at tank next to pump house on landward slope.

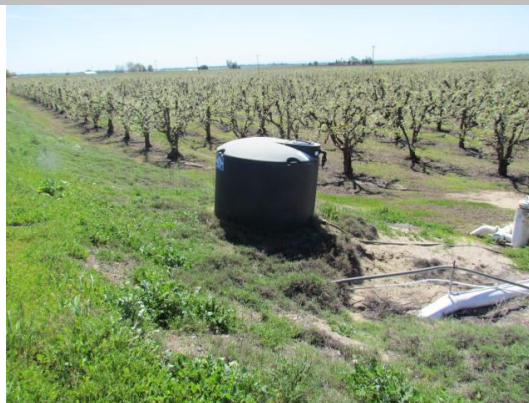
Photo 2 of 2 : SP\_2019\_RD0003\_25\_75\_20190311\_00049.jpg

LM Start	16.04	Rating **	M	Issue No.	75 (cont)	
LM End	16.04	Issue Type +	En	Location *	LS	
Category	Earthen Levee			GPS Latitude/Longitude		
				Start		End
Item	Encroachments			38.289126 °		38.289126 °
				-121.559631 °		-121.559631 °
DWR ID	DWR_RD0003_02_s_2014_75					
Comment Code						
TA : Tank						
Inspector Comment						
A tank is located next to an irrigation system on the landside slope. No permit for this tank was found.

Looking southwest at tank on landside slope.

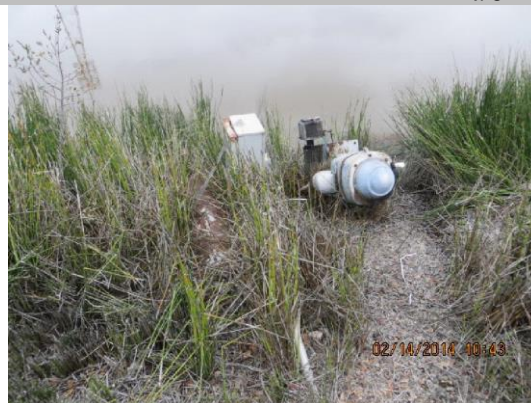
Photo 1 of 3 : UCIP\_SP\_2019\_29986\_55369.jpg

Comment Code					
Inspector Comment					
FS_ID:29986 DS_ID:22378 EP_NO: N/A Repair Type: Non-Urgent Crossing Status: Found UCIP Comments: siphon breaker on LS slope should have CMP riser protection. FIELD_STRUCT_DESC: 16-inch steel irrigation discharge pipe through the levee, 8 feet below the crown. Slant pump on the waterside (WS) slope. Siphon breaker on the landside (LS) slope. 44-inch concrete standpipe at the LS toe. 2-inch aluminum electrical conduit through the levee at the same location as the pipe. (T. Ferreira. USACE Unit No. 6, 1967). [Additional Reference(s): DWR Levee Log, 1993, referenced as 15 feet below the crown. USACE Sacramento O&M Manual 104, February 1960, (RM 31.39), 12-inch pipe, invert elevation 15 feet below the crown, referenced]. FS Date: 2/14/2014

LM Start	<b>16.34</b>	Rating **	M	Issue No.	<b>1003 (cont)</b>
LM End	<b>16.34</b>	Issue Type +	En	Location *

Slant pump and electrical conduit on WS slope.

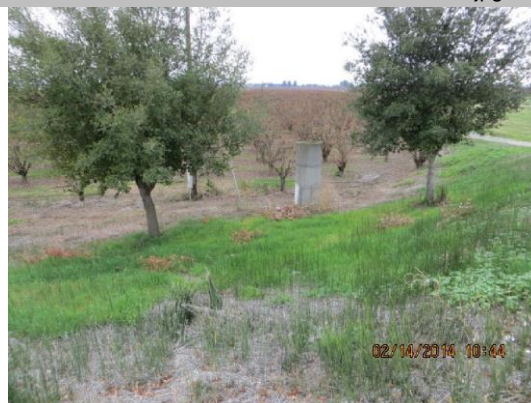
Photo 2 of 3 : UCIP\_SP\_2019\_29986\_55368.jpg

44-inch concrete standpipe on LS toe.

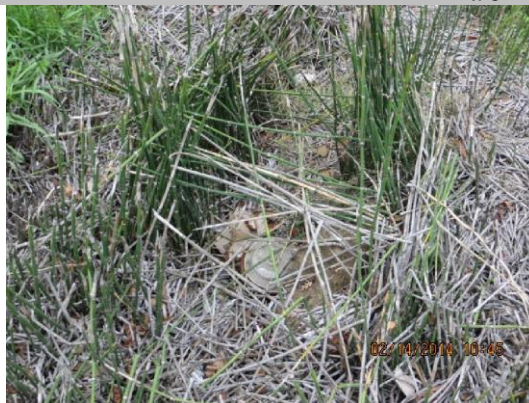
Photo 3 of 3 : UCIP\_SP\_2019\_29986\_55367.jpg

Item	DWR UCIP Field Study			38.292413 °	38.292413 °	
				-121.563301 °	-121.563301 °	
DWR ID	22378					
Comment Code						
Inspector Comment						
FS_ID:29986 DS_ID:22378 EP_NO: N/A Repair Type: Non-Urgent Crossing Status: Found UCIP Comments: siphon breaker on LS slope should have CMP riser protection. FIELD_STRUCT_DESC: 16-inch steel irrigation discharge pipe through the levee, 8 feet below the crown. Slant pump on the waterside (WS) slope. Siphon breaker on the landside (LS) slope. 44-inch concrete standpipe at the LS toe. 2-inch aluminum electrical conduit through the levee at the same location as the pipe. (T. Ferreira. USACE Unit No. 6, 1967). [Additional Reference(s): DWR Levee Log, 1993, referenced as 15 feet below the crown. USACE Sacramento O&M Manual 104, February 1960, (RM 31.39), 12-inch pipe, invert elevation 15 feet below the crown, referenced]. FS Date: 2/14/2014

Siphon breaker on LS slope

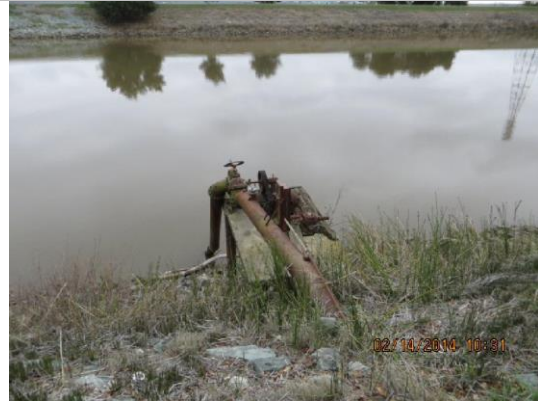
Photo 1 of 3 : UCIP\_SP\_2019\_53536\_55362.jpg

FS\_ID:53536  
DS\_ID:22380  
EP\_NO: 1075  
Repair Type: Urgent  
Crossing Status: Found  
UCIP Comments: 12/20/2018 Permit issued for removing and replacing an existing 10-inch steel pipeline with a new 10-inch steel pipeline through the levee. (A. McDonald - DWR UCIP)07/20/2018 Sinkhole is still visible on the crown roadway, but it hasn't appeared to have gotten any deeper. Sinkhole on the LS slope has been repaired. No pipe replacement has been made yet. Need to determine the pipe condition through the levee. Crossing remains "Urgent" due to signs of integrity issues. (A. McDonald - DWR UCIP)07/06/2016 Same as last inspection. Pipe to be replaced soon via CVFPB permit. (DWR UCIP - kfazel)02/14/2014 Apparent sinkhole over pipe at crown. Appears abandoned and should be done so properly. (DWR UCIP - pamatya) FIELD\_STRUCT\_DESC: 10-inch (not 12-inch as mentioned in the desk study) steel irrigation discharge pipe through the levee, invert elevation 3.7 feet below the crown. Pump and gate valve on a pier on the waterside (WS) slope. 44-inch concrete standpipe at the landside (LS) toe. 1.5-inch electrical conduit through the levee at the same location. (To install a pumping plant with a 12-inch discharge line through the levee authorized by Permit No. 1075, 1945 - R. B. Kercheval). Robert Kercheval, lindakerch@gmail.com, (916) 429-8005, with DCC Engineering Company, Inc, has applied for a replacement CVFPB permit. Contact: Emily Pappalardo, emily@dccengineering.net. (To remove and replace an existing 10-inch steel pipeline with a new 10-inch steel pipeline through the levee authorized by Permit No. 748-1, 2018 - Robert Kercheval). [Additional Reference(s): DWR Levee Log, 1993, 12-inch pipe referenced. USACE Sacramento O&M Manual 104, February 1960, (RM 31.52), 8-inch pipe referenced].

Pipe and pump on concrete pad on WS slope.

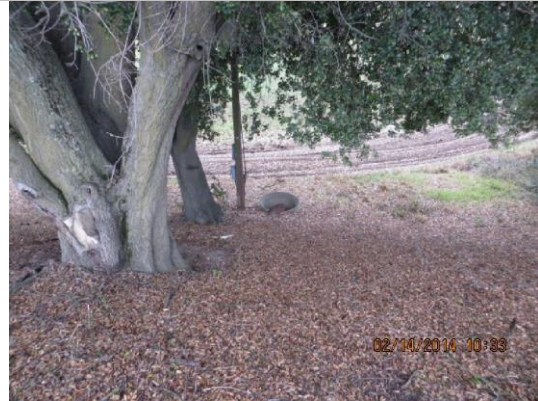
Photo 3 of 3 : UCIP\_SP\_2019\_53536\_55360.jpg

FS\_ID:53536  
DS\_ID:22380  
EP\_NO: 1075  
Repair Type: Urgent  
Crossing Status: Found  
UCIP Comments: 12/20/2018 Permit issued for removing and replacing an existing 10-inch steel pipeline with a new 10-inch steel pipeline through the levee. (A. McDonald - DWR UCIP)07/20/2018 Sinkhole is still visible on the crown roadway, but it hasn't appeared to have gotten any deeper. Sinkhole on the LS slope has been repaired. No pipe replacement has been made yet. Need to determine the pipe condition through the levee. Crossing remains "Urgent" due to signs of integrity issues. (A. McDonald - DWR UCIP)07/06/2016 Same as last inspection. Pipe to be replaced soon via CVFPB permit. (DWR UCIP - kfazel)02/14/2014 Apparent sinkhole over pipe at crown. Appears abandoned and should be done so properly. (DWR UCIP - pamatya) FIELD\_STRUCT\_DESC: 10-inch (not 12-inch as mentioned in the desk study) steel irrigation discharge pipe through the levee, invert elevation 3.7 feet below the crown. Pump and gate valve on a pier on the waterside (WS) slope. 44-inch concrete standpipe at the landside (LS) toe. 1.5-inch electrical conduit through the levee at the same location. (To install a pumping plant with a 12-inch discharge line through the levee authorized by Permit No. 1075, 1945 - R. B. Kercheval). Robert Kercheval, lindakerch@gmail.com, (916) 429-8005, with DCC Engineering Company, Inc, has applied for a replacement CVFPB permit. Contact: Emily Pappalardo, emily@dccengineering.net. (To remove and replace an existing 10-inch steel pipeline with a new 10-inch steel pipeline through the levee authorized by Permit No. 748-1, 2018 - Robert Kercheval). [Additional Reference(s): DWR Levee Log, 1993, 12-inch pipe referenced. USACE Sacramento O&M Manual 104, February 1960, (RM 31.52), 8-inch pipe referenced].

Concrete standpipe and meter on pole at LS toe.

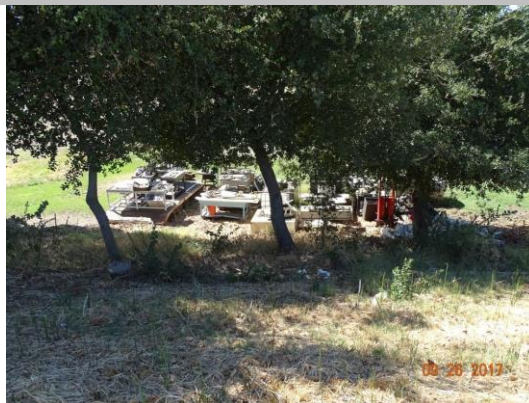
Photo 1 of 2 : SP\_2019\_RD0003\_25\_166\_20190311\_00141.jpg

LM Start	16.54	Rating **	M	Issue No.	166
LM End	16.54	Issue Type +	En	Location *	LS
Category	Earthen Levee			GPS Latitude/Longitude	
				Start	End
Item	Encroachments			38.294600 °	38.294600 °
				-121.565592 °	-121.565592 °
DWR ID	DWR_RD0003_02_f_2017_166				
Comment Code					
EQ : Equipment					
Inspector Comment					
Landowner has equipment and wood stored at toe of landside slope.

Looking southwest at the landside slope.

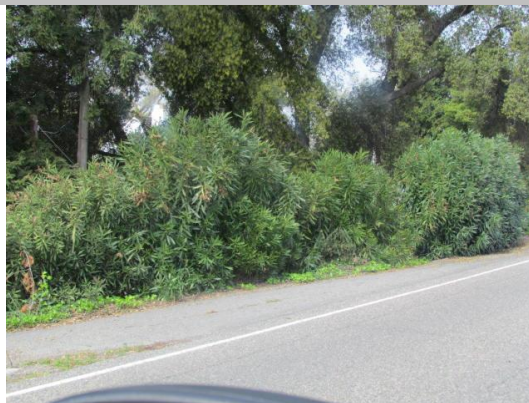
Photo 1 of 4 : SP\_2019\_RD0003\_25\_77\_20190311\_00052.jpg

Looking west at landscaping on landside shoulder and slope. (Fall 2015)

LM Start	16.58	Rating **	M	Issue No.	77 (cont)	
LM End	16.60	Issue Type +	En	Location *	LS	
Category	Earthen Levee			GPS Latitude/Longitude		
				Start	End	
Item	Vegetation			38.295082 °	38.295395 °	
				-121.566037 °	-121.566232 °	
DWR ID	DWR_RD0003_02_s_2012_77					
Comment Code						
V6 : Landscaping						
Inspector Comment						
Landowner removed oleanders, but other vegetation is still blocking the view of the landside slope and toe.

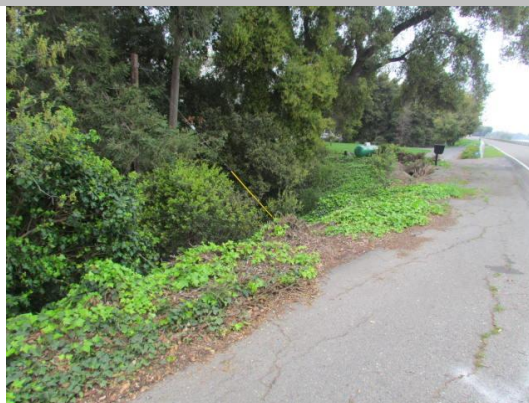
Photo 2 of 4 : SP\_2019\_RD0003\_25\_77\_20190311\_00053.jpg

Looking north at landscape on landward slope and toe. (Spring 2016)

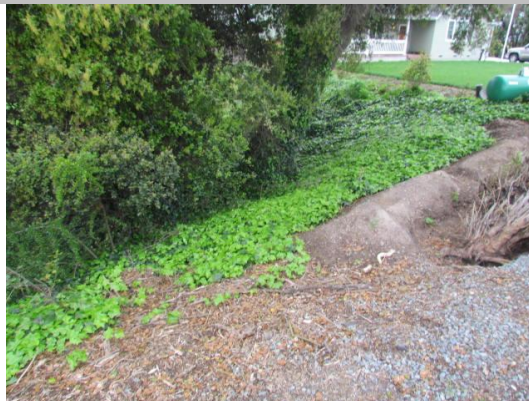
Photo 3 of 4 : SP\_2019\_RD0003\_25\_77\_20190311\_00054.jpg

Looking north at landscape on landward slope and toe. (Spring 2016)

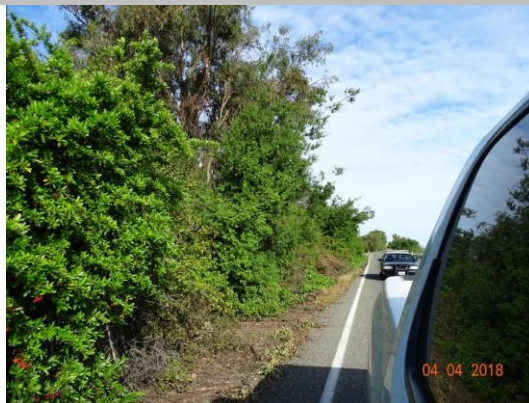
Photo 4 of 4 : SP\_2019\_RD0003\_25\_77\_20190311\_00055.jpg

Dense landside landscaping.

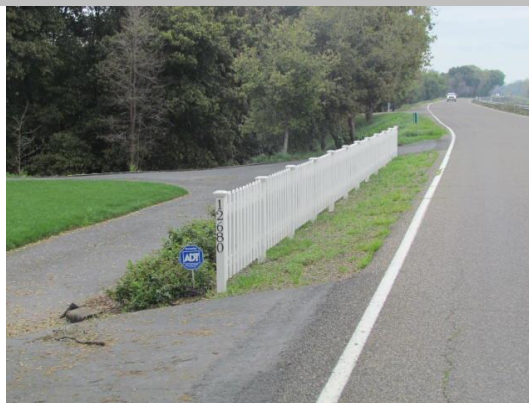
Photo 1 of 2 : SP\_2019\_RD0003\_25\_146\_20190311\_00120.jpg

LM Start	16.60	Rating **	M	Issue No.	146
LM End	16.60	Issue Type +	En	Location *	LS
Category	Earthen Levee			GPS Latitude/Longitude	
				Start	End
Item	Encroachments			38.295263 °	38.295263 °
				-121.566193 °	-121.566193 °
DWR ID	DWR_RD0003_02_s_2016_146				
Comment Code					
FE : Fence					
Inspector Comment					
Landowner installed a white fence on the landside shoulder. No permit was identified for this fence.

Looking northeast at new fence on landward slope.

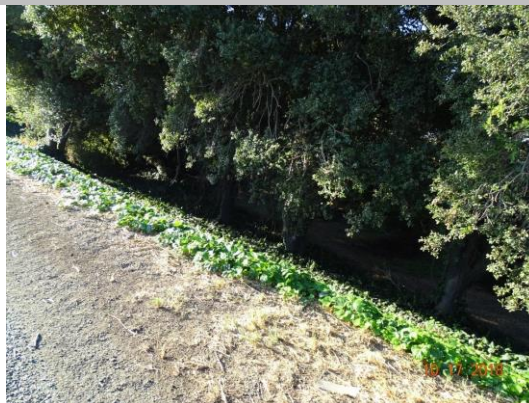
Photo 1 of 1 : SP\_2019\_RD0003\_25\_121\_20190311\_00084.jpg

LM Start	16.62	Rating **	M	Issue No.	121
LM End	16.64	Issue Type +	En	Location *	LS
Category	Earthen Levee			GPS Latitude/Longitude	
				Start	End
Item	Vegetation			38.295578 °	38.295823 °
				-121.566498 °	-121.566717 °
DWR ID	DWR_RD0003_02_f_2018_121				
Comment Code					
V6 : Landscaping					
Inspector Comment					
Remove ivy on the landside slope.

View of ivy on landside slope (October 2018).

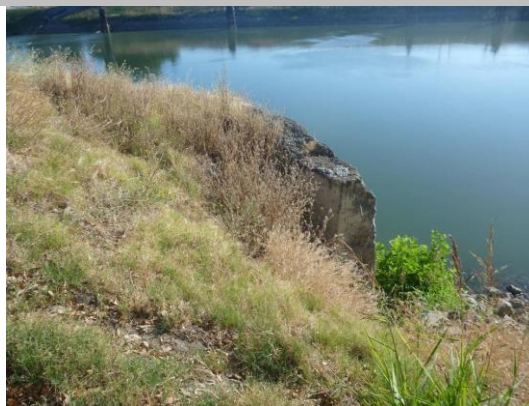
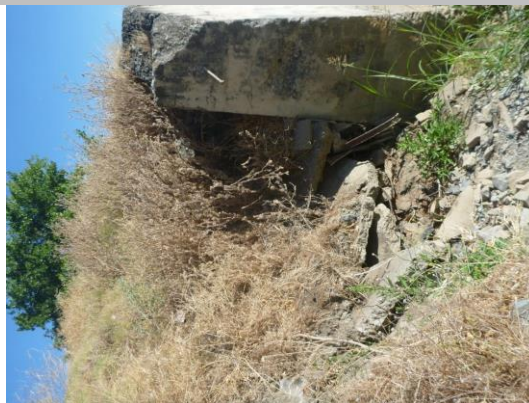
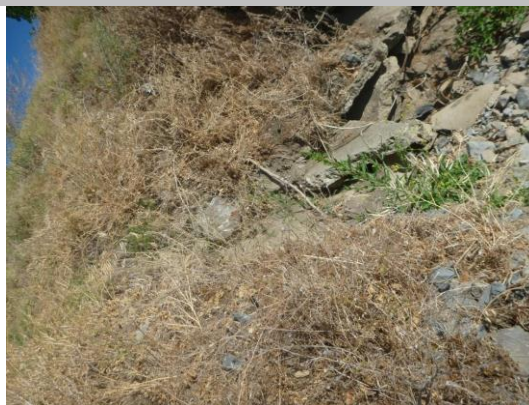
LM Start	16.90	Rating **	A/W	Issue No.	152
LM End	16.90	Issue Type +	Ma	Location *	
Category	Supplemental			GPS Latitude/Longitude	
				Start	End
Item	2017 Storm Damage			38.298914 °	38.298997 °
				-121.569156 °	-121.569217 °
DWR ID	DWR_RD0003_02_f_2017_152				
Comment Code					
Inspector Comment					
Levee Evaluation Comments					
Description:District station 892+36 to 892+70, Sec. 08, T. 5 N. R. 4 E., M.D.M. Approximately 34 linear feet of erosion exists along the water side slope of the Sacramento River (Unit 2). The erosion commences approximately 1/2 of the way down the slope from the crown and extends into the rip rap. A section of rip rap has eroded away in this location.					
Site ID No:285					
Site Designation:LMA-111					
Repair Type: Erosion					
Rating:Area of Concern					
Field Date:7/28/2017					
Notes: highway on crown

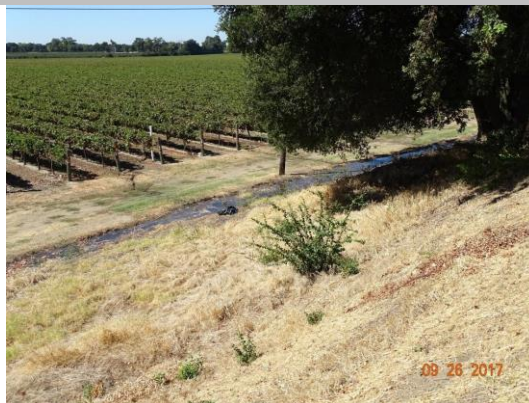
Photo 1 of 1 : SP\_2019\_RD0003\_25\_165\_20190311\_00140.jpg

LM Start	16.97	Rating **	M	Issue No.	165
LM End	16.97	Issue Type +	En	Location *	LS
Category	Earthen Levee			GPS Latitude/Longitude	
				Start	End
Item	Encroachments			38.299744 °	38.299744 °
				-121.570108 °	-121.570108 °
DWR ID	DWR_RD0003_02_f_2017_165				
Comment Code					
DT : Ditch					
Inspector Comment					
Appears that the landowner has dug a shallow trench along the toe of the levee to drain water from irrigation.

Looking northwest at the landside slope.

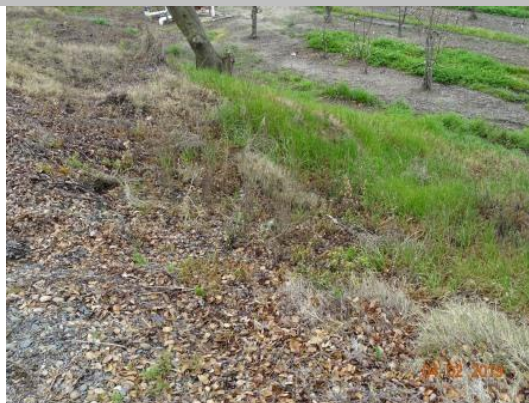
Photo 1 of 2 : SP\_2019\_RD0003\_25\_114\_20190404\_00323.jpg

LM Start	17.27	Rating **	M	Issue No.	114
LM End	17.27	Issue Type +	Ma	Location *	LS
Category	Earthen Levee			GPS Latitude/Longitude	
				Start	End
Item	Slope Stability			38.303351 °	38.303351 °
				-121.573084 °	-121.573084 °
DWR ID	DWR_RD0003_02_s_2019_114				
Comment Code					
S1 : Repair slope instability.					
Inspector Comment					
There is a depression on the landside slope.

View looking downstream at depression on the landside slope (Spring 2019).

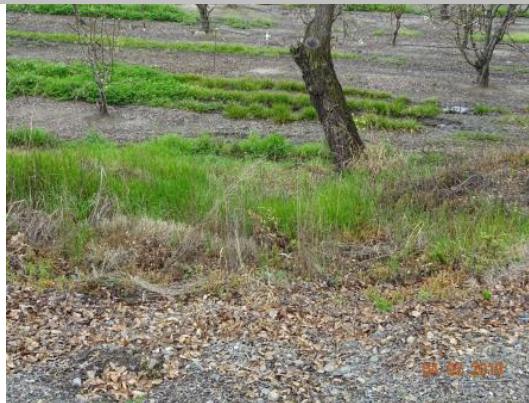
Photo 2 of 2 : SP\_2019\_RD0003\_25\_114\_20190404\_00324.jpg

View looking downslope at depression on the landside slope (Spring 2019).

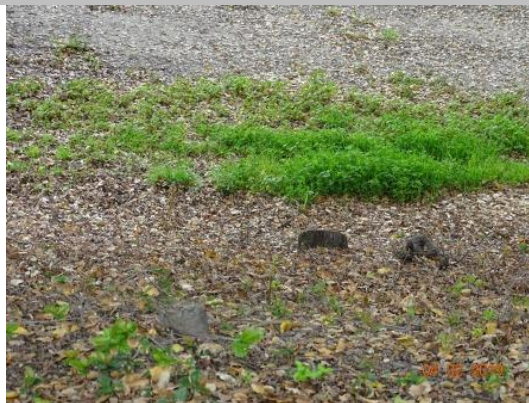
Photo 1 of 1 : SP\_2019\_RD0003\_25\_113\_20190404\_00322.jpg

LM Start	17.29	Rating **	N	Issue No.	113
LM End	17.29	Issue Type +	Ma	Location *	LS
Category	Earthen Levee			GPS Latitude/Longitude	
				Start	End
Item	Trim / Thin Trees			38.303558 °	38.303558 °
				-121.573380 °	-121.573380 °
DWR ID	DWR_RD0003_02_s_2019_113				
Comment Code					
T5 : Tree stumps.					
Inspector Comment					
There is a tree stump about 6" at bottom of the levee slope.

View looking downslope at tree stumps on the landside (Spring 2019).

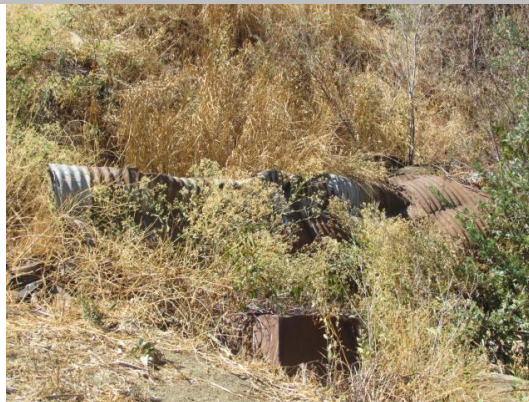
Photo 1 of 1 : SP\_2019\_RD0003\_610\_1\_20190311\_00001.jpg

LM Start	0.02	Rating **	M	Issue No.	1
LM End	0.02	Issue Type +	En	Location *	WS
Category	Earthen Levee			GPS Latitude/Longitude	
				Start	End
Item	Encroachments			38.182059 °	38.182059 °
				-121.653608 °	-121.653608 °
DWR ID	DWR_RD0003_03_f_2015_1				
Comment Code					
GA : Garbage					
Inspector Comment					
There is a discarded pipe on waterward slope.

Looking at discarded pipe on waterward slope.
